Periodic Inspection of Nawiliwili Harbor Breakwater, Kauai, Hawaii

Armor Unit Monitoring for Period 1995-2001

Robert R. Bottin, Jr., and Daniel T. Meyers

June 2002

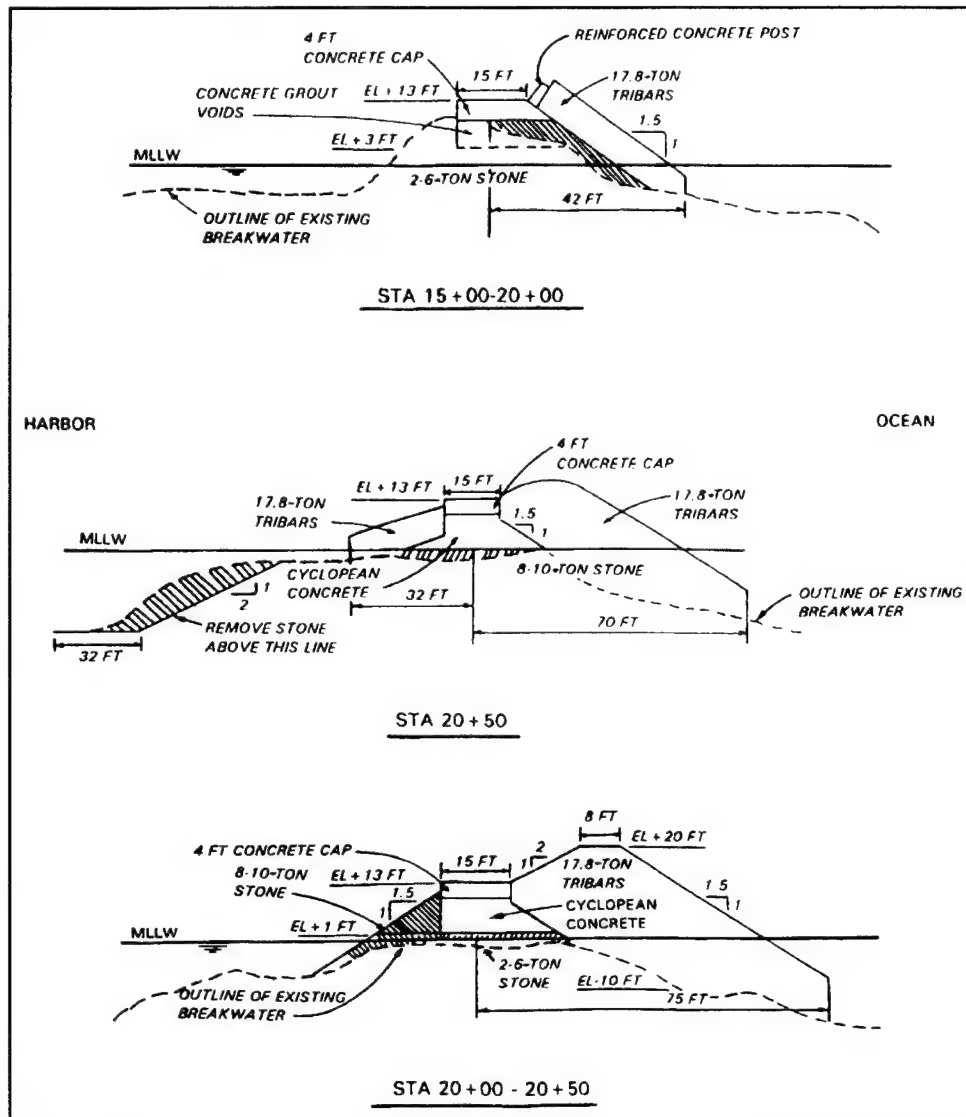
Figure 5. Typical cross sections for 1959 breakwater repairs

The 1959 rehabilitation utilized 16,150-kg (17.8-ton) tribar armor units. A two-layer, random placement was used on the head and outer 15.2 m (50 ft) of the structure, and uniformly placed, single layer placement was used along 152 m (500 ft) of trunk on the sea-side slope (stas 15+00 - 20+00). A concrete cap also was poured on the crest of the breakwater in 1959 with a crest el of +4.0 m (+13 ft). Typical cross sections for the 1959 repair are shown in Figure 5. The wave height used for design of the armor units for the 1959 rehabilitation was 7.3 m (24 ft). Of the 598 tribars placed, 351 were reinforced. The Corps tagged 150 of the tribars for indicators of movement on the slope during future surveys. After the rehabilitation was completed, Hurricane Dot struck Kauai. It was reported that the structure survived with only minor damage. Three tribars were broken, and

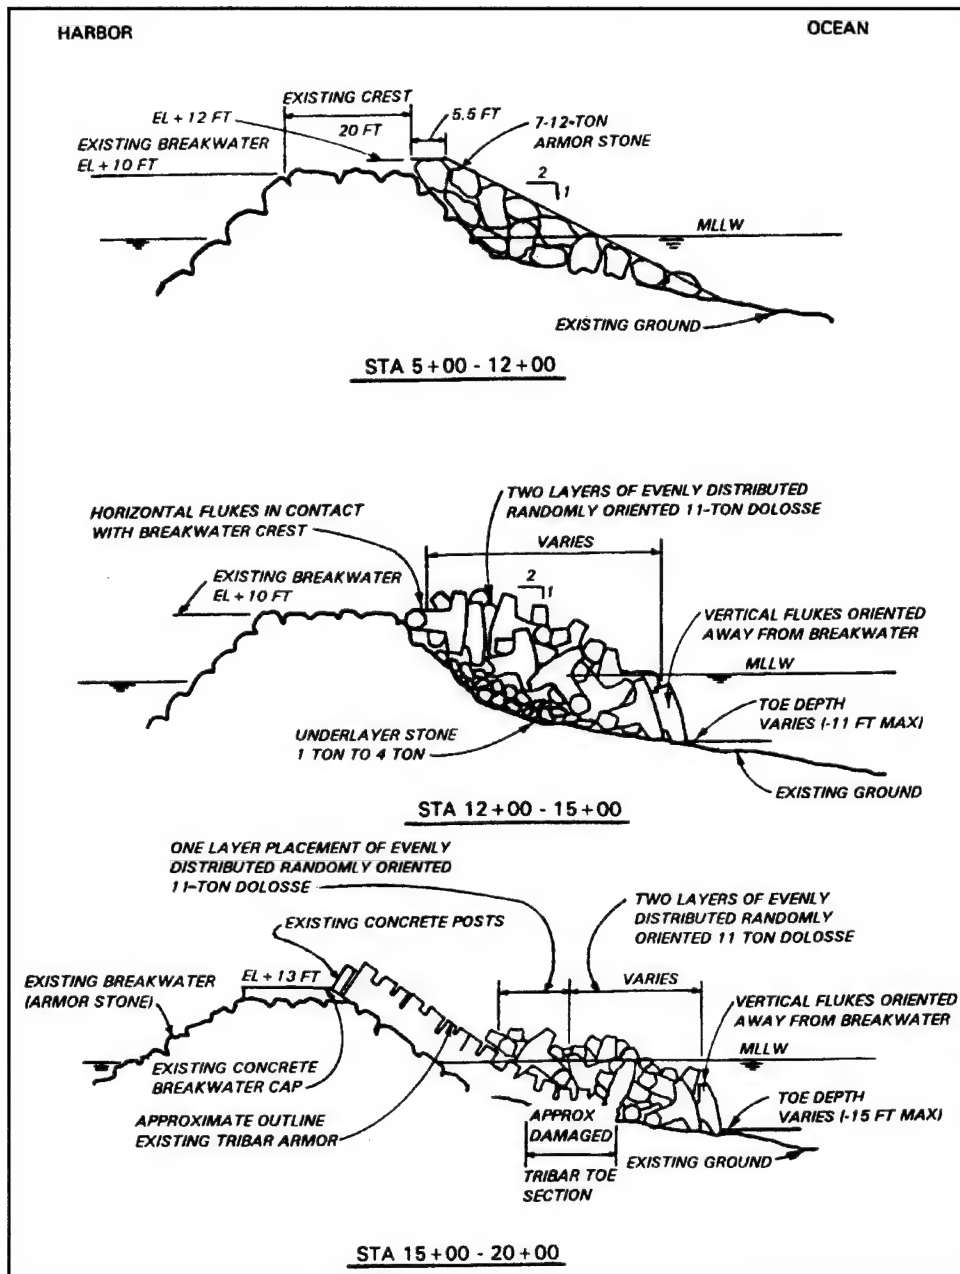
Figure 6. Typical cross sections for 1977 breakwater repairs

Due to continued damage to the breakwater, another rehabilitation was initiated in 1977. It consisted of the use of 9,980-k (11-ton) dolos armor units. Two layers of unreinforced dolosse (485 units) were placed from the toe to approximately +1.5 m (+5.0 ft) over the one-layer tribar trunk section (stas 15+00 - 20+00). In addition, two layers of dolosse (449 units) were placed from the toe to the crest on the sea-side slope of the trunk for a distance of 91 m (300 ft) shoreward of the tribar area (stas 12+00 - 15+00). Model testing (Davidson 1978) found the dolosse to be hydraulically stable. The sea-side slope shoreward of the dolosse (sta 5+00 - 12+00) also was repaired with 6,350-10,890-k (7-12-ton) stone during the rehabilitation. Cross sections of the 1977 repairs are shown in Figure 6. A breakwater survey conducted in 1980 indicated that the breakwater was in good condition with minimal armor unit breakage observed.

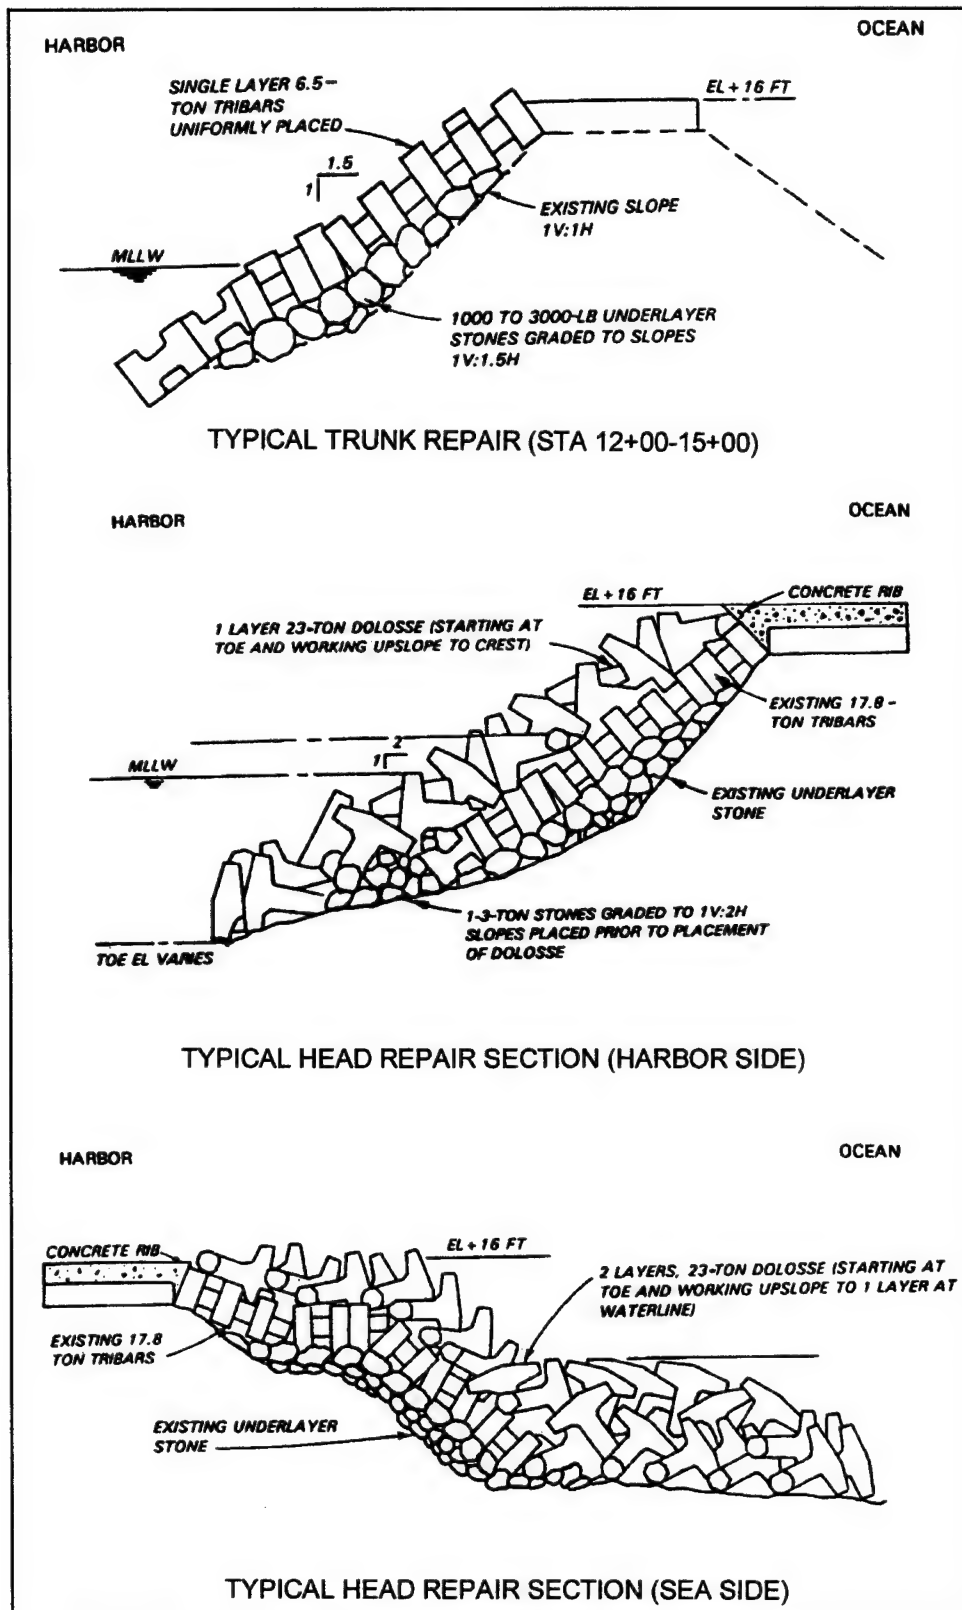
Figure 7. Typical cross sections for 1987 breakwater repairs

In 1987, the breakwater was rehabilitated with 20,865-kg (23-ton) reinforced dolosse (230 units). These units were placed along the steepened head section below the water surface and randomly in low areas around the existing head above the waterline. On the harbor-side slope, one layer of 5,900-kg (6.5-ton) tribars was placed along a portion of deteriorated trunk (stas 12+00 - 15+00). This

design was model tested (Markle and Herrington 1983), and it was determined that it provided adequate stability. In addition, a 260-m-long (850-ft-long) concrete rib cap was constructed (stas 12+00 - 20+50) to buttress the concrete armor units. Cross sections of the 1987 repairs are shown in Figure 7.

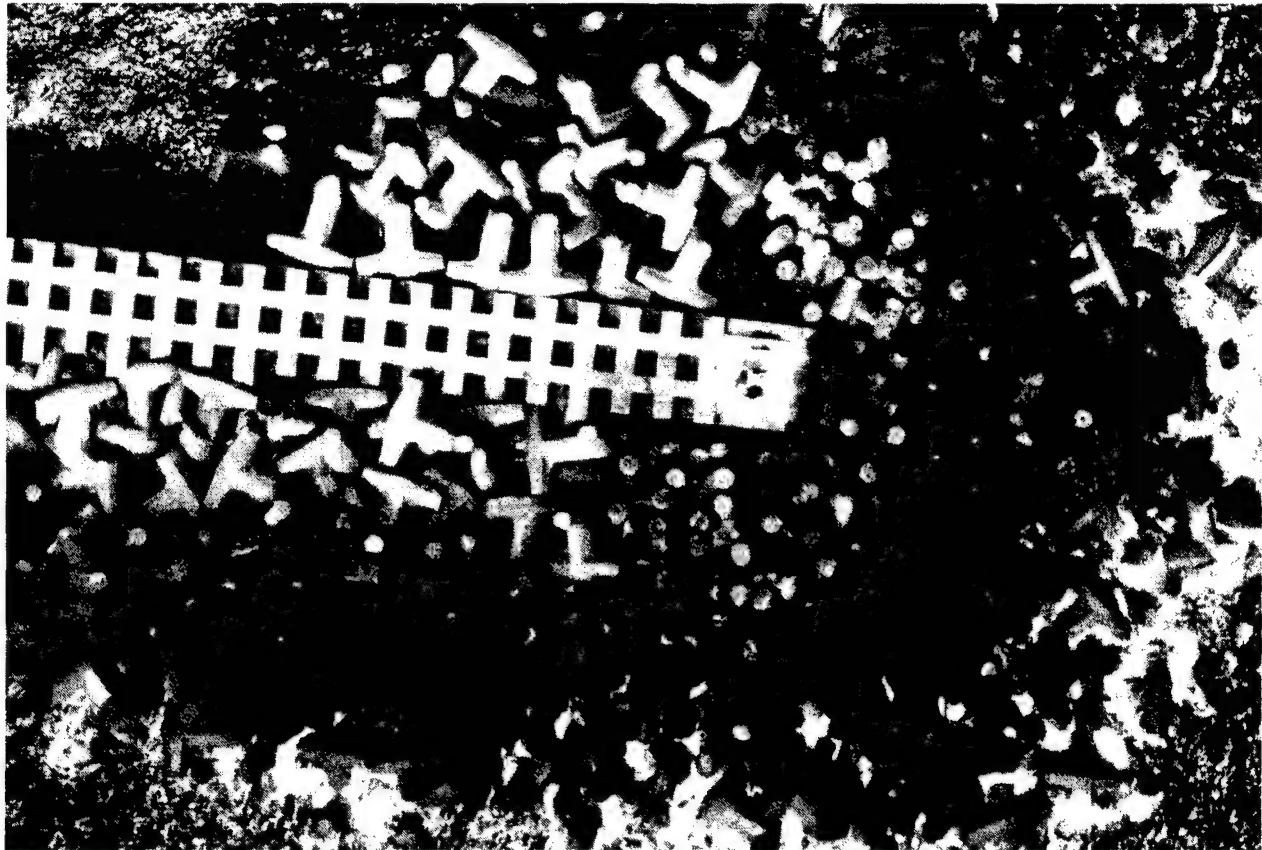
Figure 17. Photo map of head of Nawiliwili breakwater

Photo maps combine the image characteristics of a photograph with the geometric qualities of a map. The image is rectified and free from skewness and distortion, and therefore, precise horizontal measurements may be obtained using an engineer scale. Photo maps were prepared for the outer 260-m (850-ft) length of the Nawiliwili breakwater for the 2001 survey. They were produced on Mylar sheets at a scale of 1:240. An example of a photo map of the head of the Nawiliwili breakwater is shown in Figure 17. In an effort to quantify movement of nontargeted concrete armor units, photo maps obtained for the 1995 and 2001 surveys were compared. It appeared that negligible movement of nontargeted units had occurred between the surveys.

In summary, detailed and accurate information relative to the armor unit positions for the Nawiliwili Harbor breakwater have been captured by means of aerial photography and photogrammetric analysis. Comparisons of 2001 target data to that obtained previously in 1995 indicated horizontal movements ranging from 0.0 to 0.013 m (0.0 to 0.42 ft) and vertical movements ranging from 0.0 to 0.137 m (0.0 to 0.45 ft). Additional comparisons of 2001 centroid data to that of 1995 revealed horizontal movements ranging from 0.0 to 0.104 m (0.0 to 0.34) and vertical movements ranging from 0.0 to 0.113 m (0.0 to 0.37 ft). These data indicate that negligible movement of the targeted concrete armor units occurred between 1995 and 2001. Additionally, comparison of nontargeted armor units on the rectified photo maps indicated negligible movement.

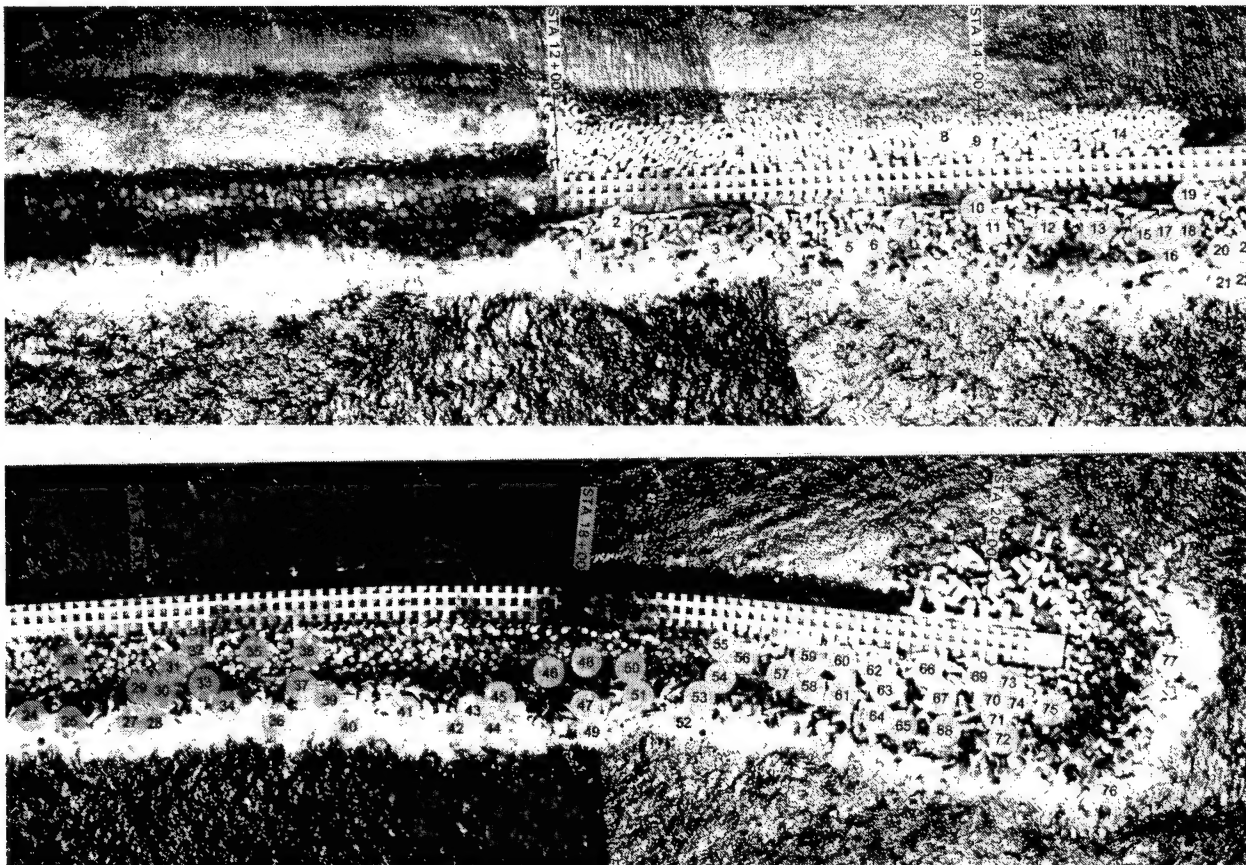
Figure 18. Approximate locations of broken/cracked armor units along outer portion of Nawiliwili Harbor breakwater

The approximate locations of broken/cracked armor units along the outer portion of the breakwater are shown in Figure 18, and detailed data obtained during the broken armor unit inventory are shown in Table 5. Armor unit numbers identified in Figure 18 correspond to those listed in Table 5. As shown, broken units occur along the entire length on the sea side of the structure, but in general, are more concentrated along the seaward end of the breakwater. Fifty-seven percent of the broken units are located on the outer half of the structure, and 27 percent of the broken units are situated on the outer 45.7-m (150-ft) length of the breakwater (sta 19+00 - 20+50). With regard to distance from baseline, the majority of broken units (71 percent) are located between 7.6 and 18.3 m (25 and 60 ft) seaward of the baseline. These units are in the active wave zone.

Of the 77 broken or cracked armor units, 44 were 9,980-kg (11-ton) dolosse, 21 were 16,150-kg (17.8-ton) tribars, 8 were 20,865-kg (23-ton) dolosse, and four were 5,900-kg (6.5-ton) tribars. Considering the types of breaks, 39 percent (17 units) of the 9,980-kg (11-ton) dolosse had mid-shank breaks, 32 percent 14 (units) had shank-fluke breaks, and 29 percent (13 units) had fluke-shank breaks. Of the eight broken 20,865-kg (23-ton) dolosse, four had mid-shank breaks, three had shank-fluke breaks, and one had a fluke-shank break. Of all the dolosse breaks recorded, 75 percent were straight and 25 percent were angled. Of the 21 broken 16,150-kg (17.8-ton) tribars, 16 (76 percent) consisted of at least one leg broken off through the center of the unit. The four broken 5,900-kg (6.5-ton) tribars on the harbor side of the breakwater appeared to have been placed in that condition. They seemed to have been fitted on the crest adjacent to the rib cap.

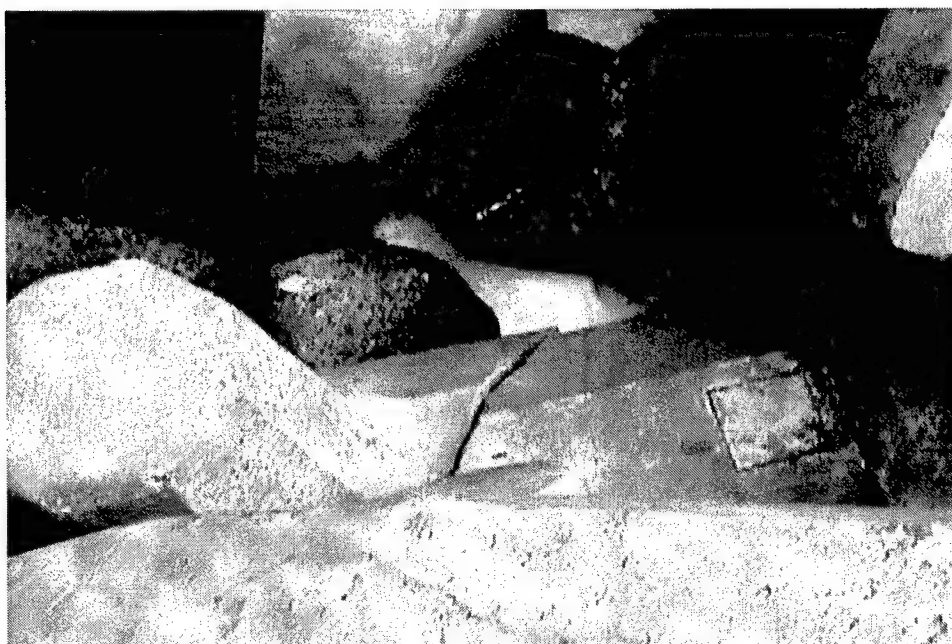
Types of breaks for the dolosse included shank and fluke breaks. These were characterized as mid-shank, shank-fluke (shank broken in vicinity of fluke), and fluke-shank (fluke broken off at junction with shank). Also recorded were straight breaks (broken straight across) and angled breaks (broken at some angle to the dolos limb). For the tribars, types of breaks included those through the center section of the unit where one or more legs were separated from the unit, and those in which just a portion of one of the legs was broken off. Views of representative types of breaks for the armor units are shown in Figures 19-22. Armor units with hairline cracks on one side were not counted, only those that were cracked all the way through were considered a break for recording purposes.

Figure 19. Dolos with mid-shank break

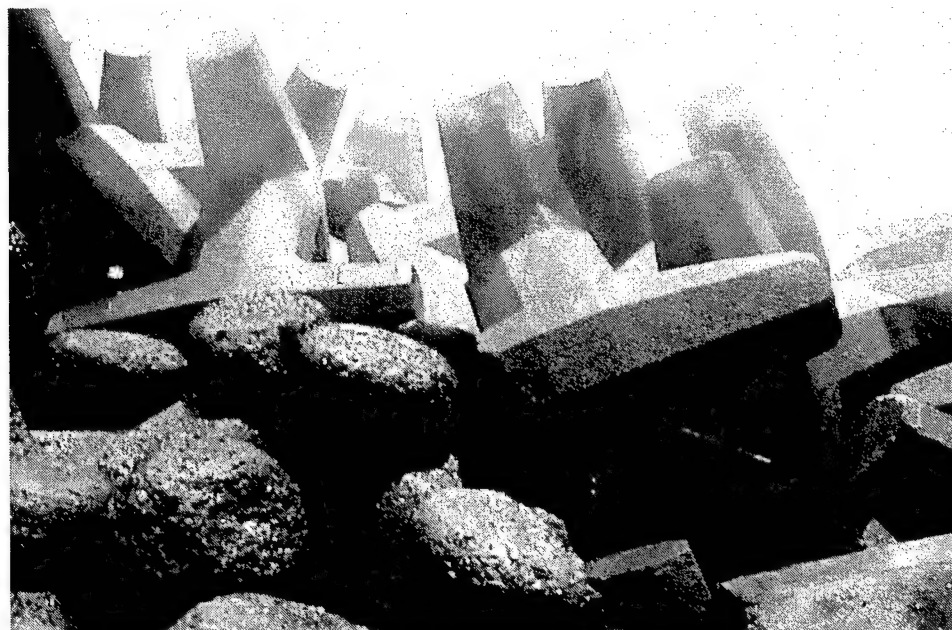
Figure 20. Dolos with fluke-shank break

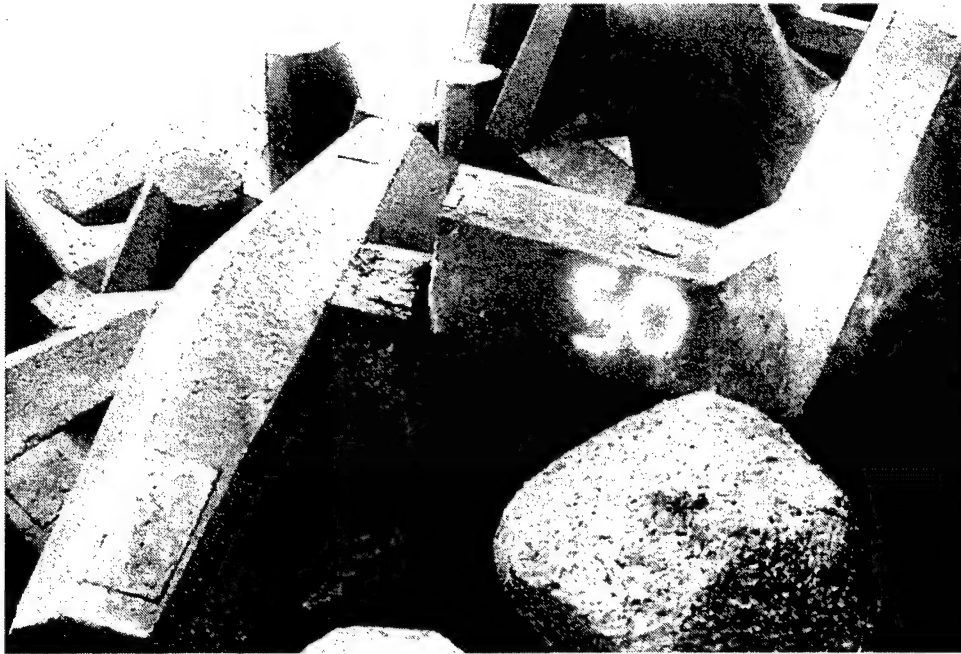
Figure 21. Dolos with shank-fluke break

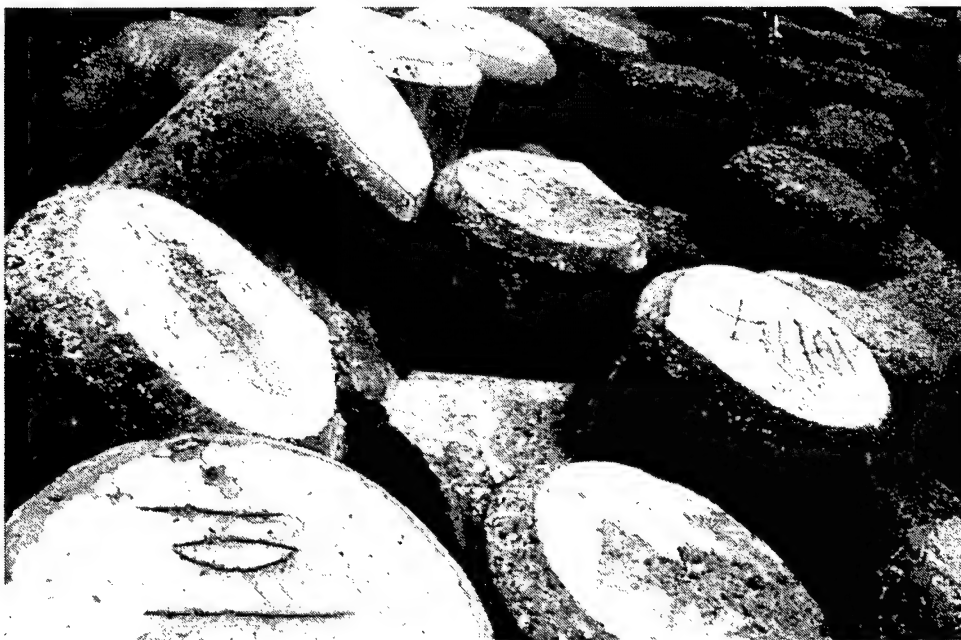
Figure 22. Tribar with break through center section of unit
